# EVERCARE™ TECHNOLOGY

**A NEW GENERATION OF SURFACE  
TREATMENT**

## **PATENTED GERFLOR TECHNOLOGY**

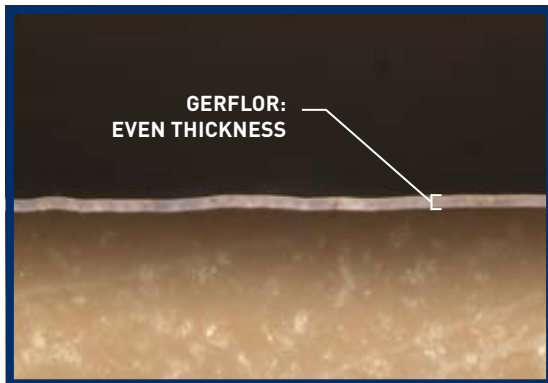
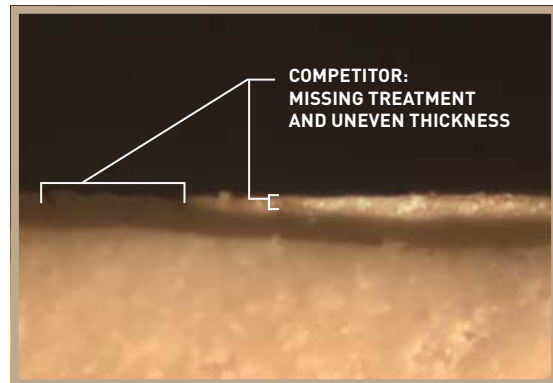
**Treatment durability**

Cross-section viewed under a microscope

*To ensure regular barrier against soiling and staining aggression*

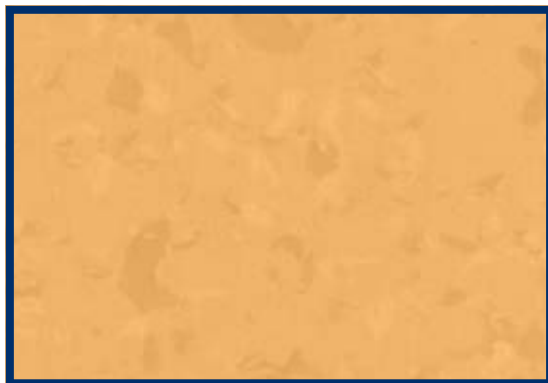
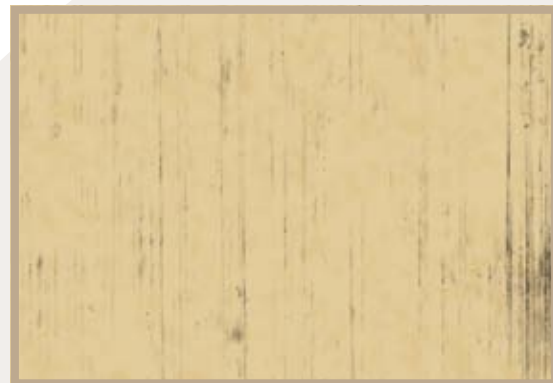
**Scratch resistance**

4 kg weight dragged on P100 sandpaper

*Optimum level against micro scratches for enhanced appearance*

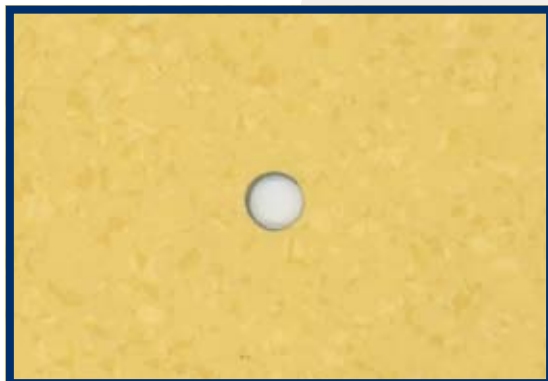
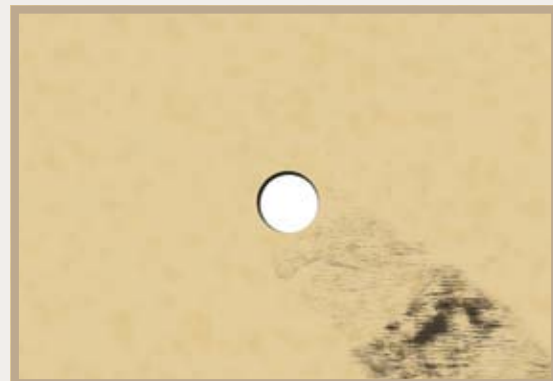
**Abrasion resistance**

Taber wear test 1,000 rpm/15 minutes

*Highest durability and extended life expectancy*
